TECHNICAL SERVICE BULLETIN

TSB No. 210-2417 ed. 4	Date April 2006	9-5
Distr. all

Oil leakage from engine

Saab 9-5 M98 - M03 with engine variants B205 and B235

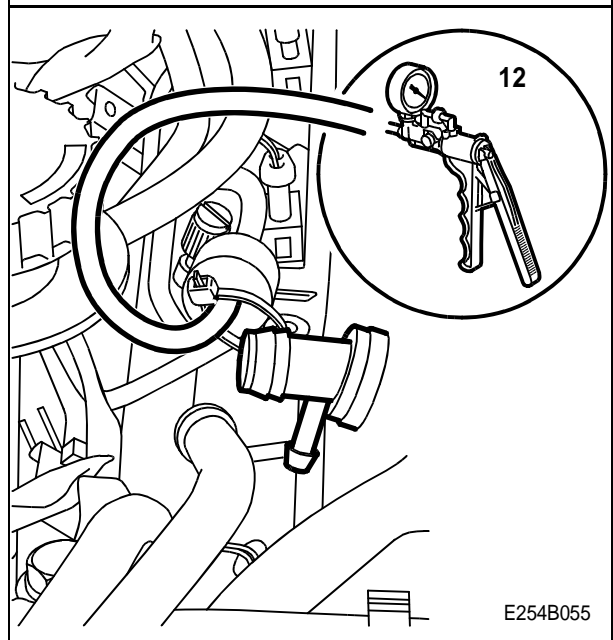
Arrow's direction on the check valve.

- 12 Check the function of the check valve on the small circuit with 30 14 883 Pressure/Vacuum pump, replace if necessary. The arrow must point toward the throttle body.
